Marconi Phase 2 Packages

Gilles Mahout and Tony Weidberg

16 December 1999

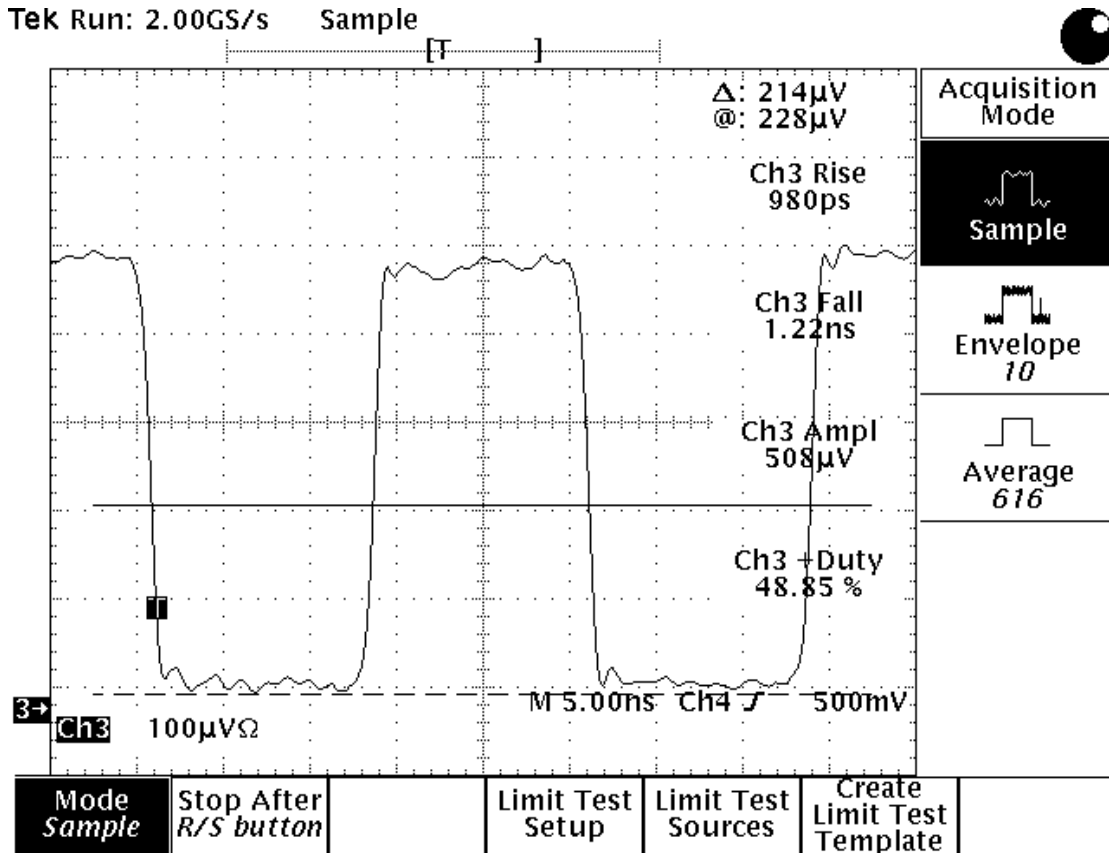
Figure 1 VCSEL1 scope trace using the optical probe.

The first of the Marconi phase 2 opto-packages contains 2 VCSELs and one PIN diode. Unfortunately the bond wire on the PIN diode lifted off before delivery of the package. We have measured the performance of the VCSELs and both channels are very good. Scope pictures of the VCSELs being driven at 10 mA (see figs below) show very clean waveforms and fast rise and fall times. Most of the waveforms were taken at a clock frequency of 20 MHz (corresponding to 40 Mbits/s data rate for the SCT) but clean traces were also obtained for 40 MHz (corresponding to the 80 Mbits/s required for the Pixel detector).

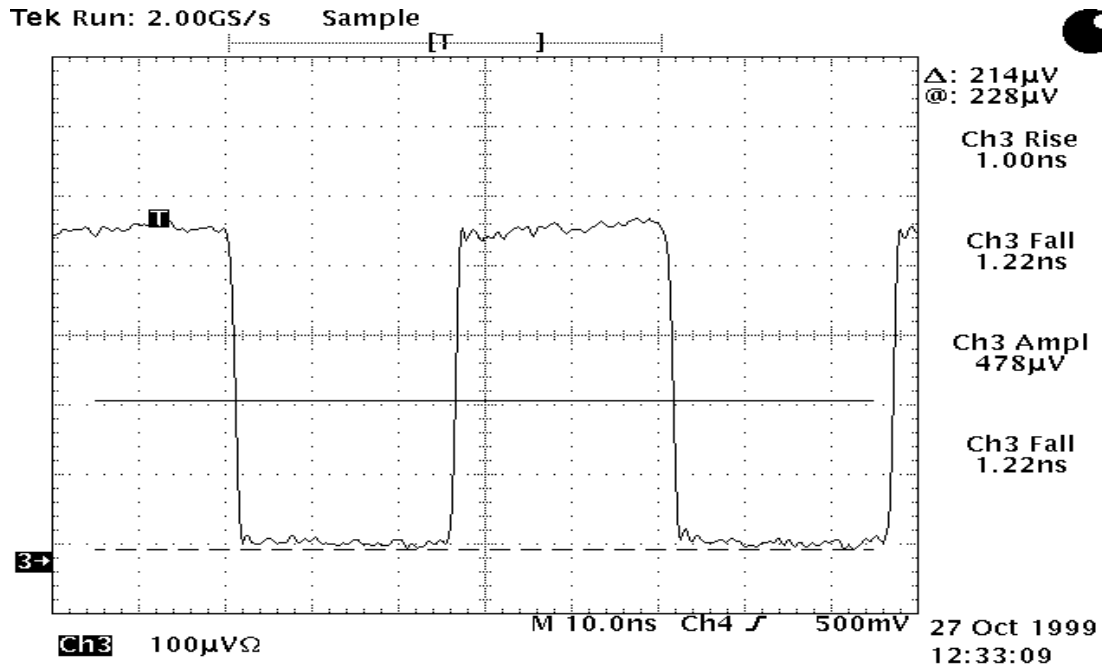
Figure 2 VCSEL 2 scope trace using the optical probe.

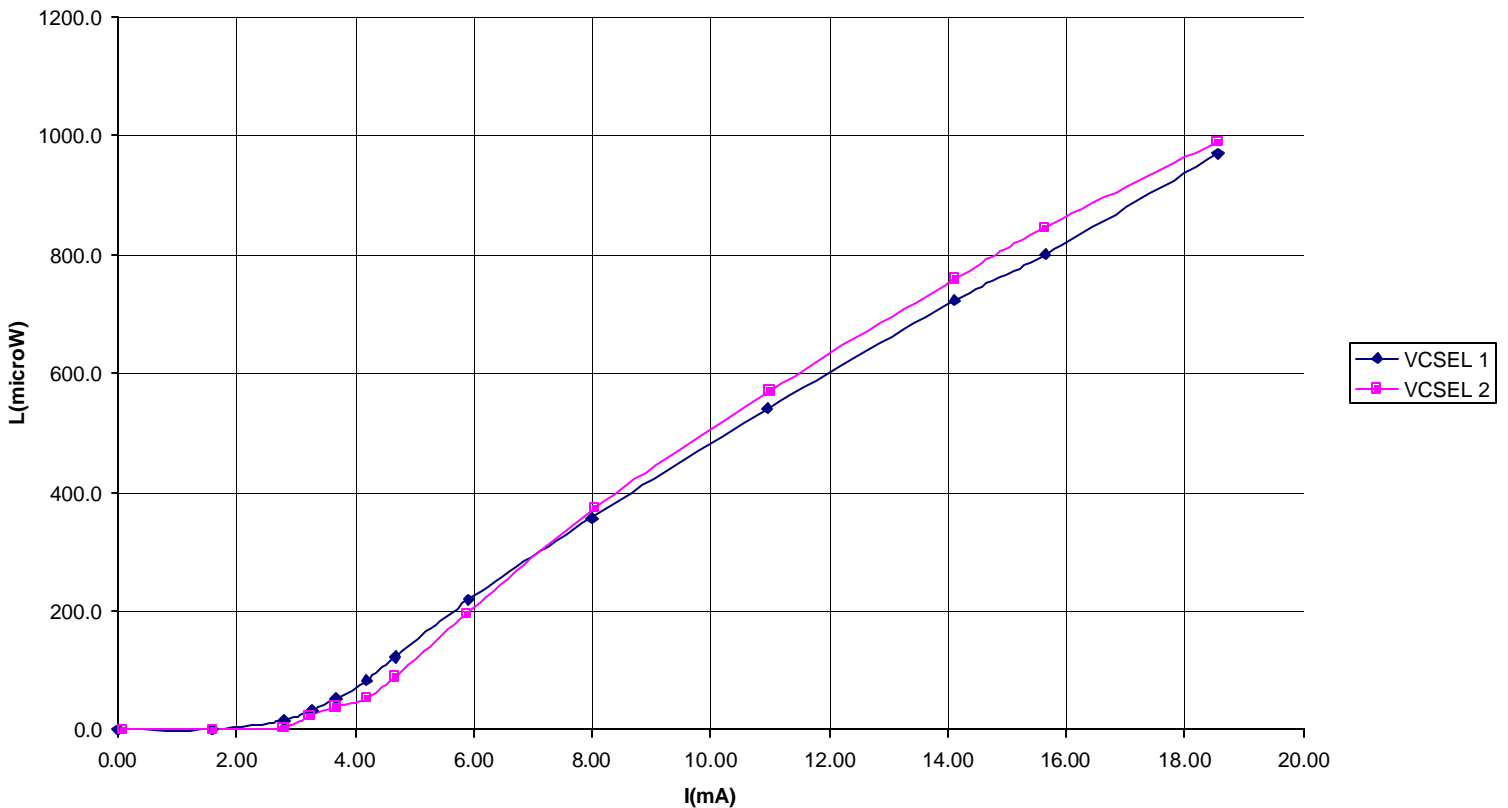
The ac LI curves were measured with the optical probe and the results for the two VCSELs are shown below (the input clock frequency was 20 MHz corresponding to the 40 Mbits/s data rate).

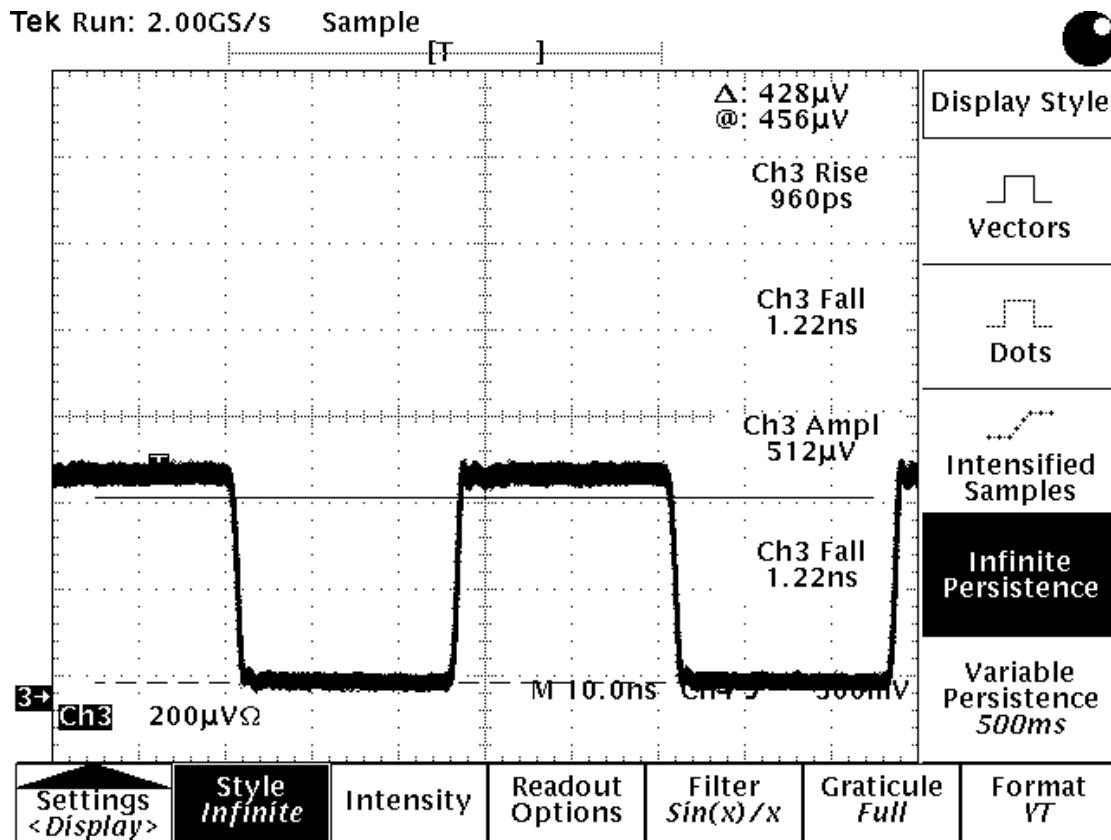
Figure 4 'scope infinite persistence plot of VCSEL output measured with an optical probe.

To check the noise and stability of the VCSEL scope pictures were taken at 10 mA

drive current with infinite persistence (see figure below). The output was stable and there was no significant laser noise.

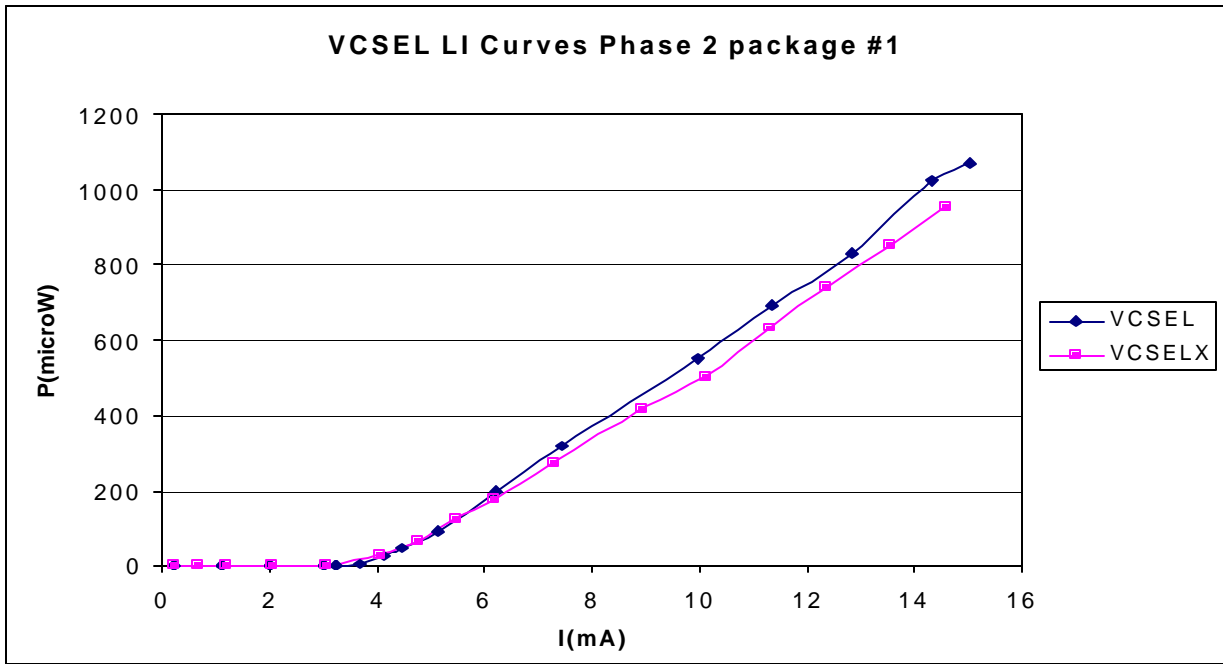
Figure 5 LI curves for VCSELs in package #1

Both PINs and VCSELs worked on these two packages. The LI curves for the VCSELs were measured and are shown in Figure 5 and Figure 6 below.

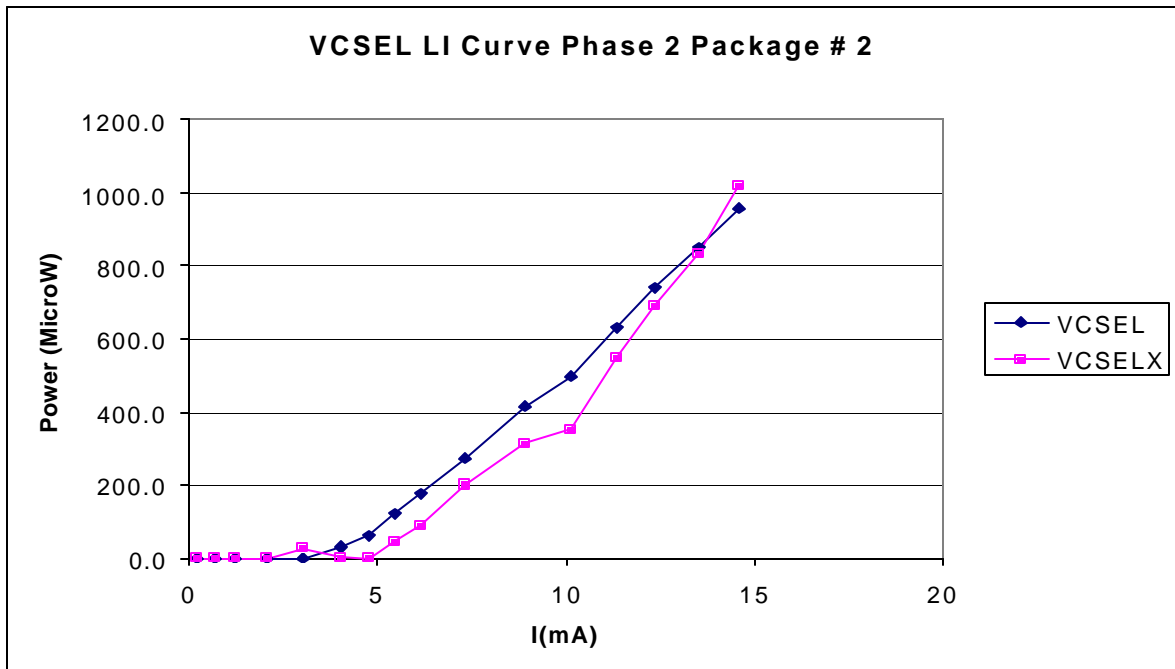
Figure 6 LI curves for VCSELs in package # 2

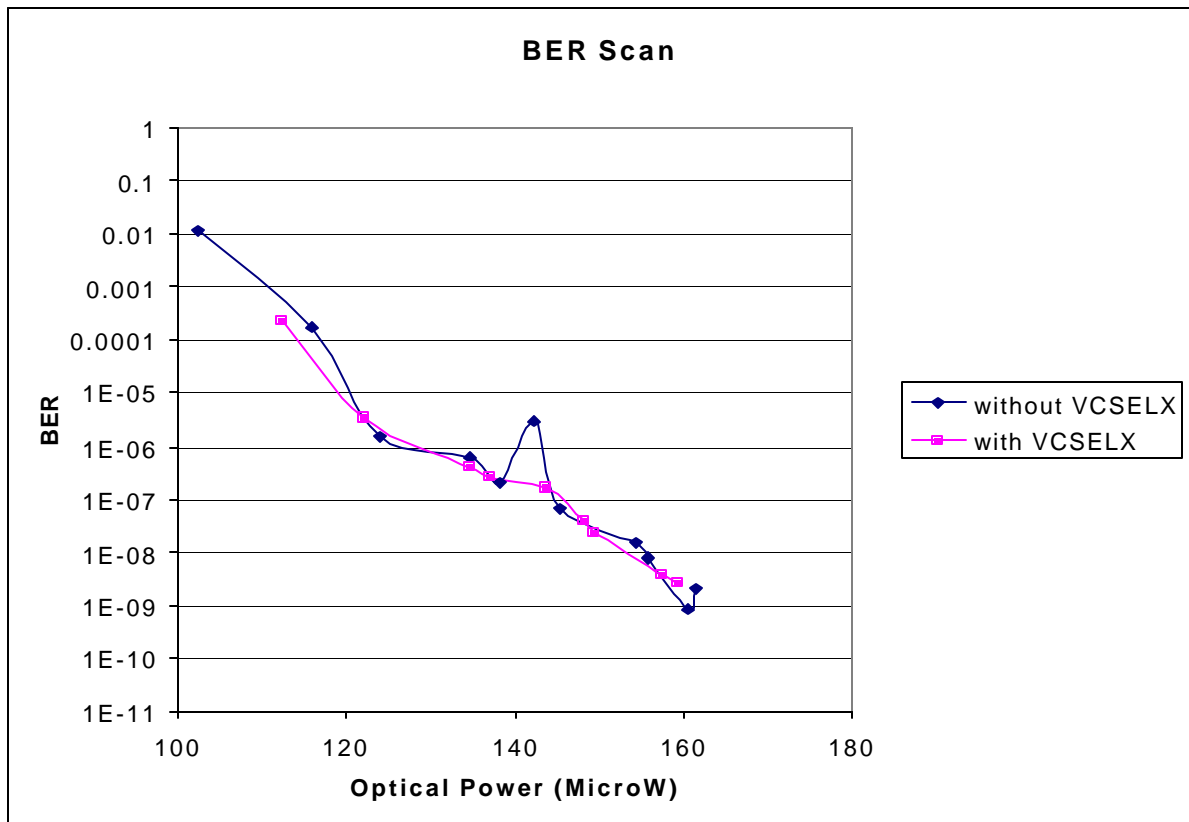
Figure 7 BER as a function of optical power into the TTC link.

The Bit Error Rate (BER) was measured in a loop back mode where TTC data were sent to the PIN and decoded by DORIC4. The decoded data was sent to one channel of the VDC chip and the output of the VCSEL was attenuated and sent to the Rudge receiver. The BER was measured as a function of the amplitude of the optical TTC signal and the results are shown in Figure 7. The BER falls to below 10^{-9} for an optical power of about 160 μW which is within the specifications for DORIC4 operation. The measurements were repeated while simultaneously sending asynchronous 20 MHz pulses to the other channel of the VDC chip. In order to simulate the worst case conditions the VDC drive current was set to 20 mA. There is no significant difference between the two curves in Figure 7, therefore we can conclude that there is no measurable cross-talk.

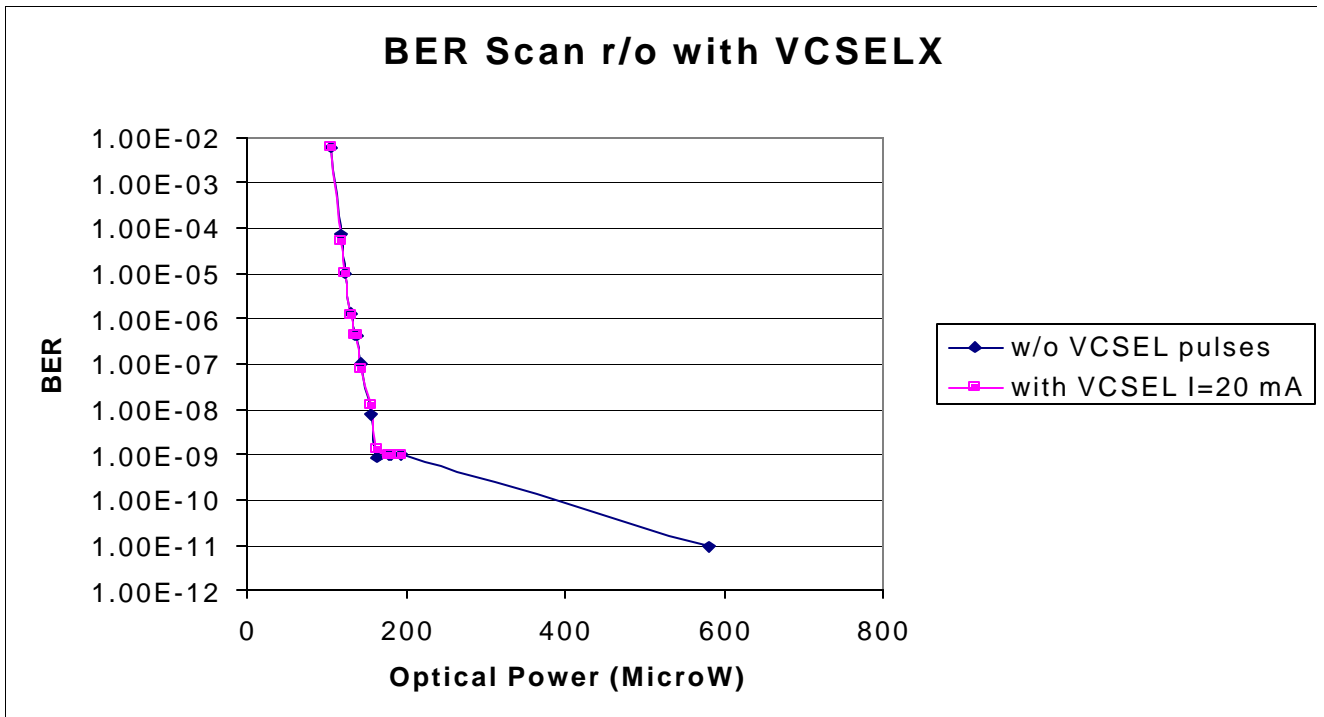
Figure 8 BER scan with readout via VCSELX and with and without pulsing VCSEL. The last point at the highest power corresponds to no observed bit errors in 45 minutes.

The results for a similar scan with readout via VCSELX, with and without pulsing VCSEL are shown in below. Again there is no evidence of any cross-talk.

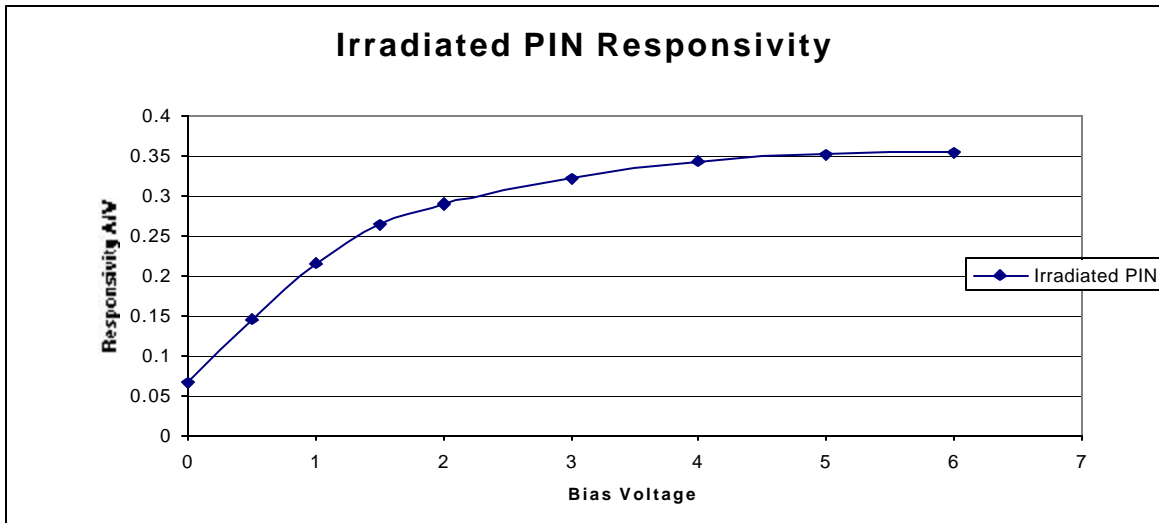
Figure 9 Responsivity versus bias voltage for the PIN diode in the irradiated package.

The responsivity of the PIN diode in package #1 as a function of bias voltage is

shown in Figure 9 . The behaviour is quite compatible with the studies of radiation hardness of PIN diodes mounted on ceramic tiles.

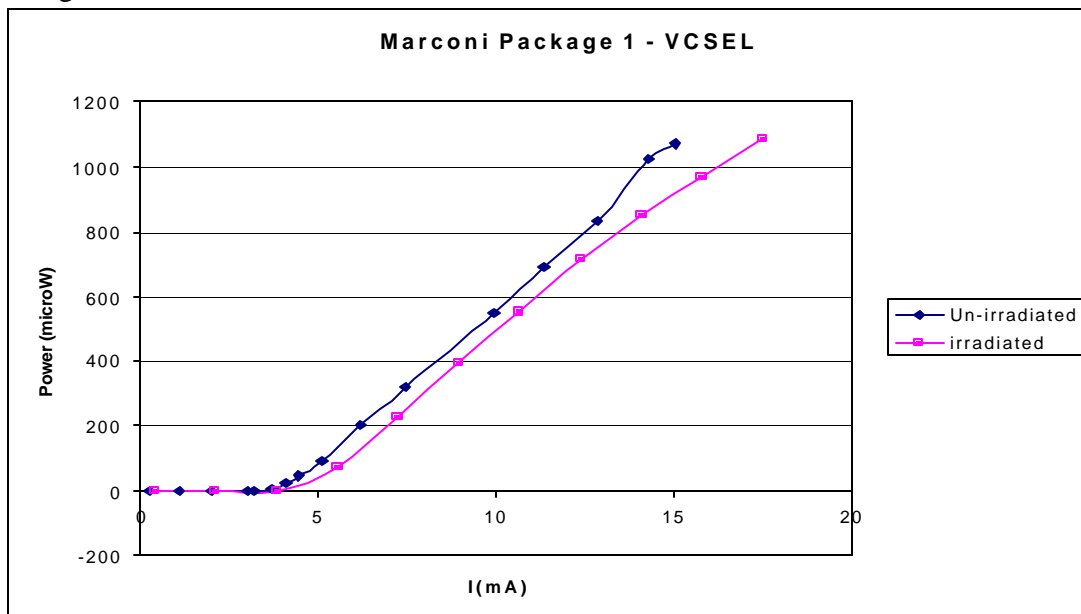
Figure 10 LI Curve for VCSEL in package 1 before and after irradiation.

As expected the VCSELs showed large threshold shifts after the irradiation but annealed rapidly when operated at 20 mA. The annealing saturated after about 100 hours. The LI curves for the VCSELs in the irradiated packages were measured (after annealing) and compared with the LI curve before irradiation. The results are shown in Figures 10 to 13 below.

The data have the expected small threshold shift after irradiation and annealing but show no significant changes in slope efficiency. The shape of the optical waveform was measured with an optical probe and showed no significant differences compared to unirradiated VCSELs. If there had been any radiation induced problems on the packaging, this would have decreased the VCSEL to fibre coupling efficiency and hence reduced the slope efficiency. Therefore we can conclude that the package is radiation hard up to the fluences expected for the SCT.

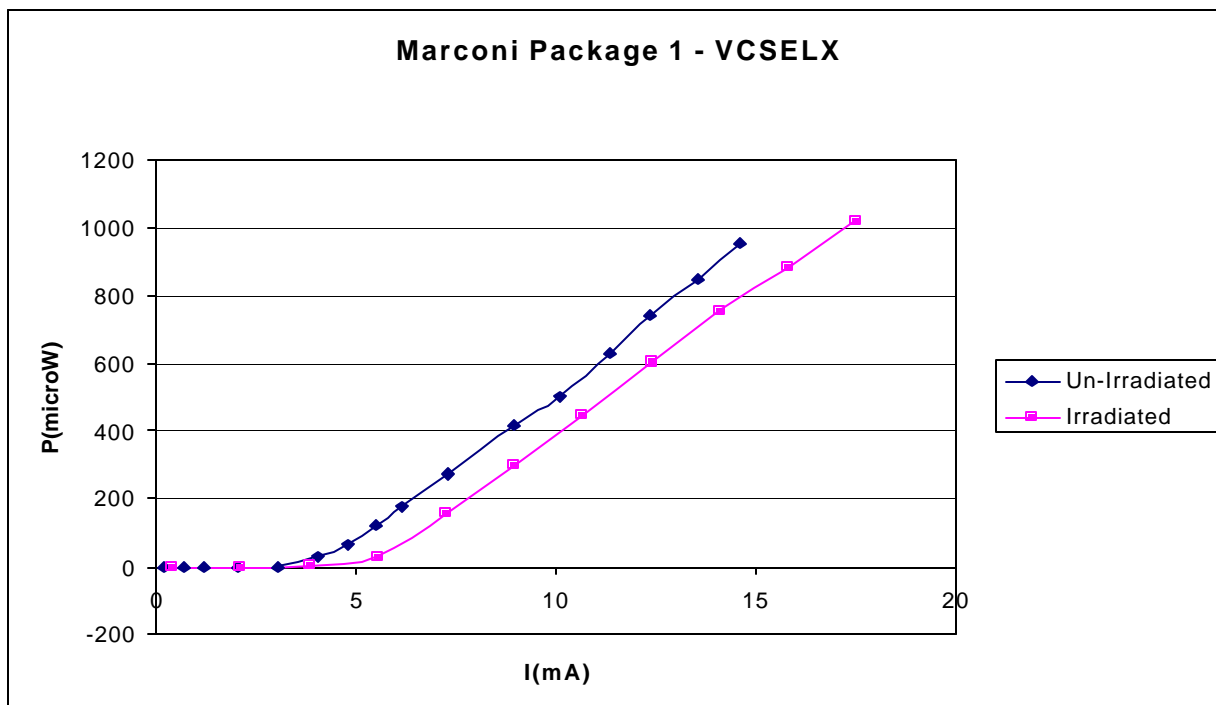
Figure 11 LI Curve for VCSELX in package 1 before and after irradiation.

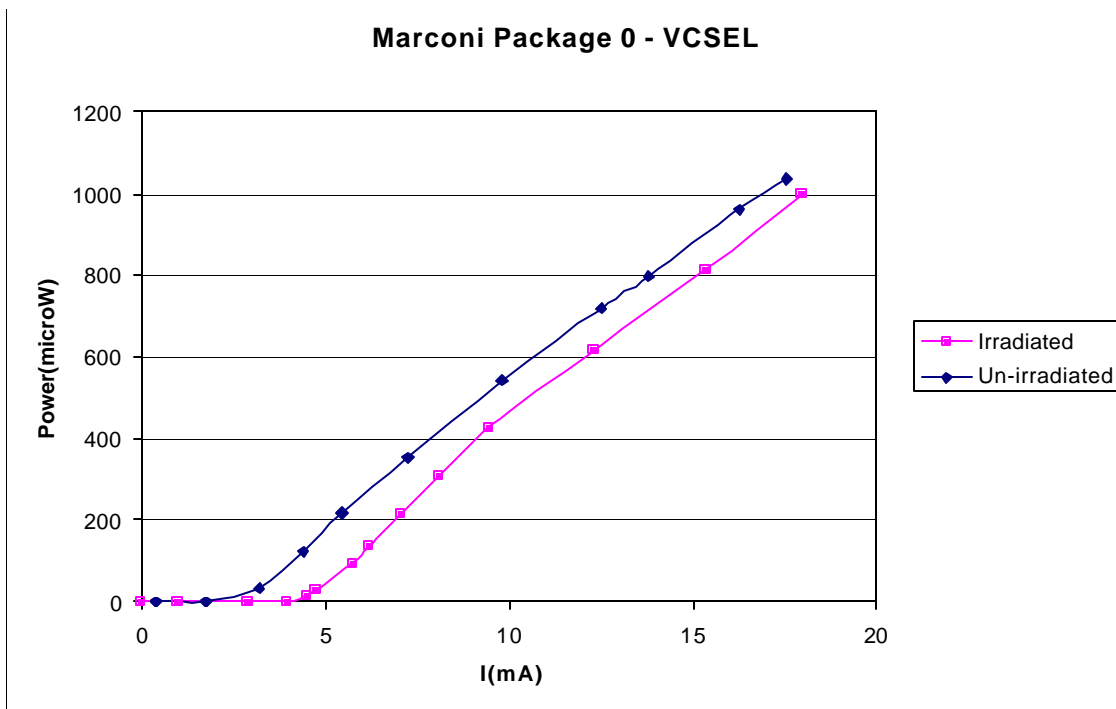
Figure 12 LI Curve for VCSEL in package 0 before and after irradiation.

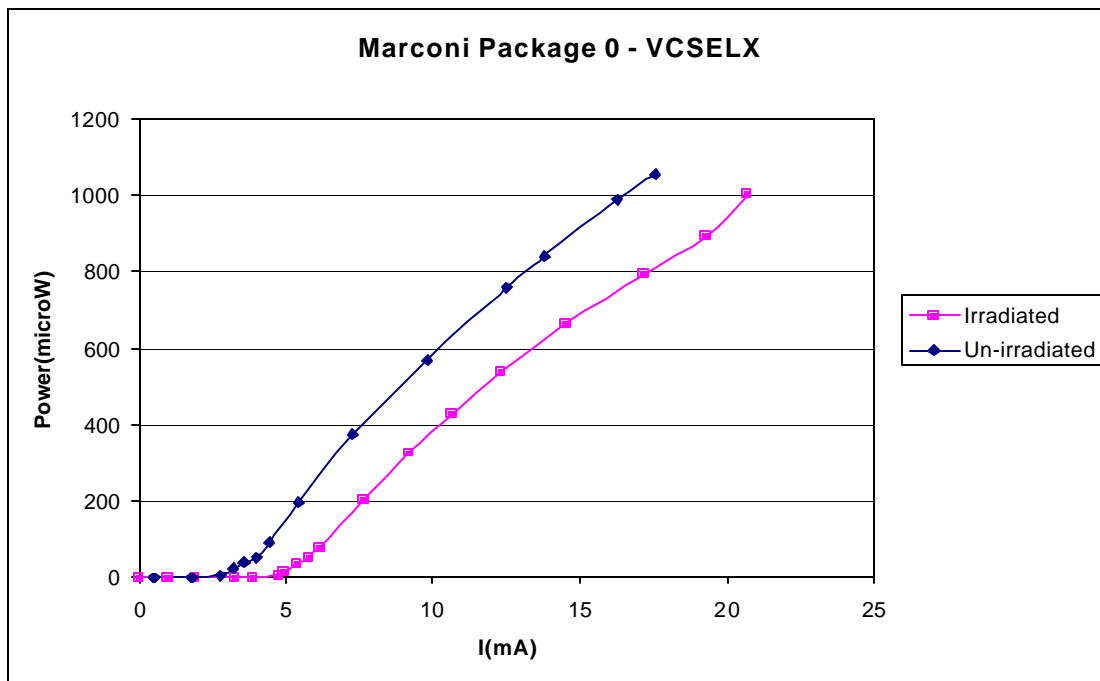
Figure 13 LI Curve for VCSELX in package 0 before and after irradiation.

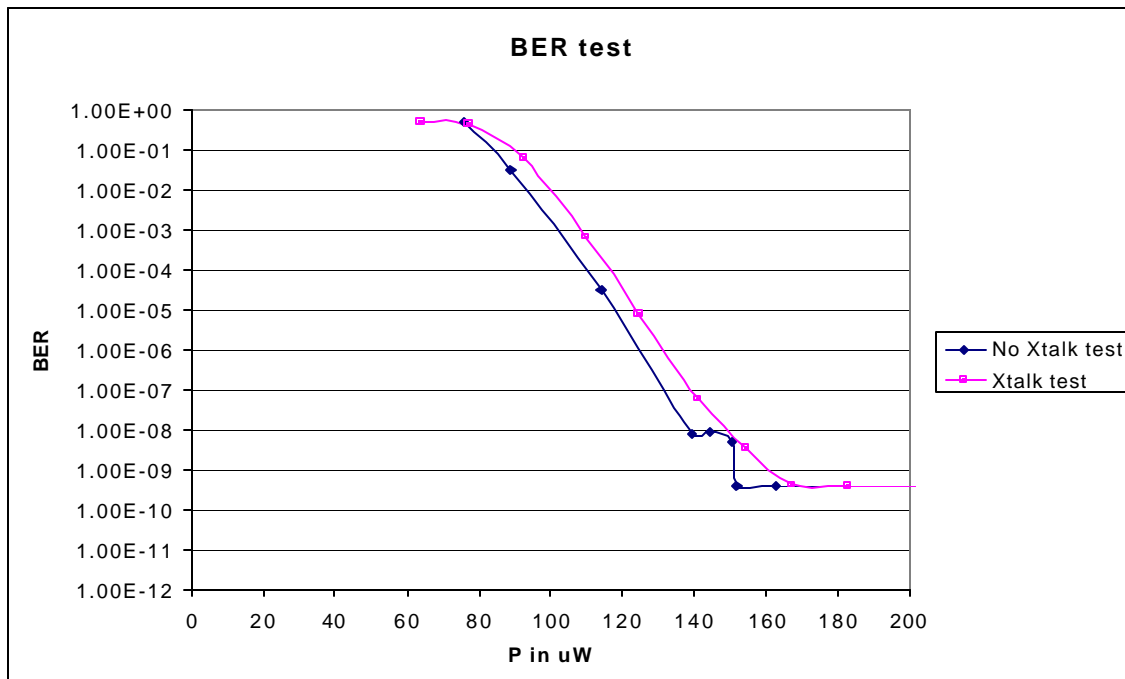
Figure 14 BER versus optical power for the TTC link as a function of the optical power input. The VCSELX was pulsed with 20 mA at 20 MHz for the cross-talk

The BER was measured using the irradiated package #1 and very good results were obtained as is shown in Figure 14 below.

The results show that the package works very well after the irradiation. The performance is significantly better than the specification which states that the BER should be less than 10^{-9} for an optical power of 200 μ W (for an irradiated PIN diode).
